Inspection Report

123 Sample Lane, Anywhere, WA 98000

Inspection Date: 5/9/2017 **Report ID:** 123SampleLane

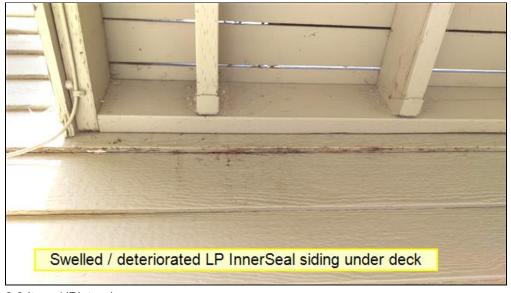
2.0 Item 1(Picture)

(1) Repair / Potential Major Issue: What appears to be LP InnerSeal composite siding was noted installed on this home. Deteriorated LP siding, with the possibility of underlying structural damage, was noted at the high-exposure southern building face that should be further evaluated by qualified contractors to make necessary repairs. This was evidenced by obvious deterioration, soft spots, characteristic swelled composite siding and edge-checking. Approximately 10-25 percent of the exterior siding appears to require replacement at this time (confirm with qualified contractor). Additionally, peeling/cracked paint at the bottom lap edge of siding boards and failed caulking details at exterior penetrations and abutments should be properly sealed (painted and caulked) by a qualified painting contractor, one familiar with LP InnerSeal composite siding painting requirements, to prevent further damage and extend serviceable life. LP InnerSeal siding is a product that was subject to class-action lawsuit for premature failure and elevated maintenance requirements. Well and proactively maintained (e.g., painted and caulked) this siding product will deliver years of serviceable life, but it does require elevated maintenance. Further evaluation of all LP InnerSeal siding by a qualified contractor- one familiar with LP InnerSeal siding- is advised to further evaluate and make necessary repairs. See attached pictures/video.

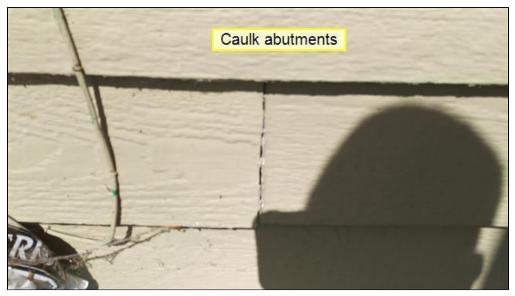
2.0 Item 6(Picture)

(2) **REPAIR**: Caulk siding/siding, trim/trim and siding/trim abutments to prevent water/insect damage. Monitor caulking annually and re-caulk if cracks in caulking are noted. See attached picture.

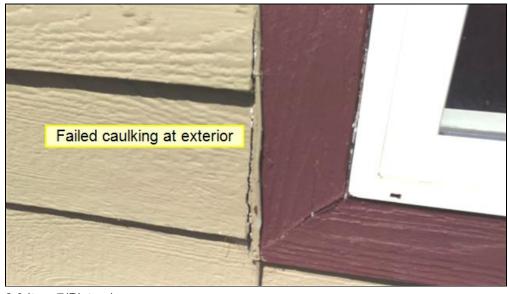
2.0 Item 7(Picture)

- (3) **Repair**: As stated above, peeling/cracked paint and failed caulking details around the perimeter of the home should be further evaluated by a qualified contractor to ensure that all exterior elements are properly sealed.
- (4) **REPAIR**: Failed caulk noted at some exterior penetrations. Caulk around all exterior penetrations (e.g., windows, doors, utility penetrations, etc.) to prevent water intrusion and insect damage. This is considered an annual maintenance issue to monitor and re-caulk as necessary. Failure to properly seal exterior penetrations can lead to underlying concealed structural damage. See attached picture.

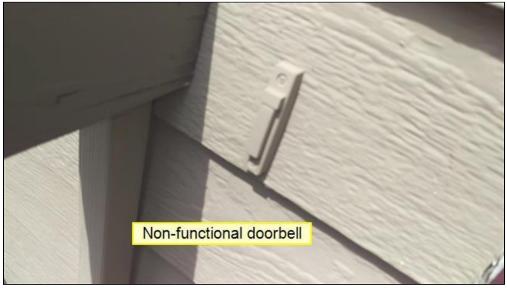
2.1 Item 1(Picture)

(1) **REPAIR**: The doorbell did not function at the time of inspection. See attached picture.

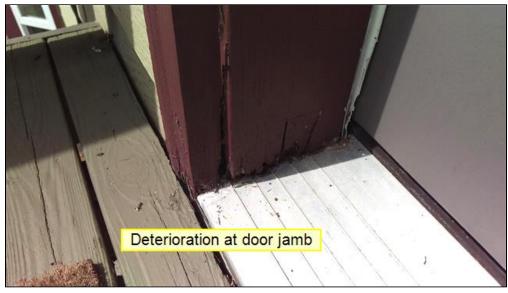
2.1 Item 2(Picture)

(2) **REPAIR**: Deterioration noted at exterior door jamb. This was noted at the upper southern exterior door jamb. See attached picture.

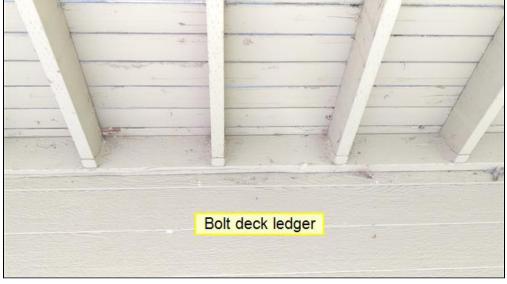
2.3 Item 1(Picture)

(1) Improve: Bolting the deck ledger to the rim joist of the home is advised for improved security. Additionally, flashing the deck ledger is advised at this traditionally vulnerable area to water intrusion and damage. See attached picture.

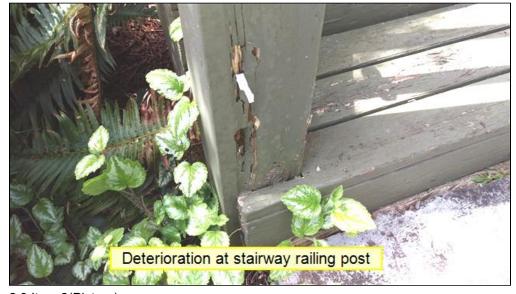
2.3 Item 2(Picture)

(2) **Repair**: I recommend you have a qualified contractor further evaluate the deck systems to make necessary repairs. Some items noted include: (1) deterioration was noted at the stairway railing; (2) select repair and replacement of deteriorating deck boards is advised as necessary; (3) deterioration was noted on portions of the upper-deck railing system; (4) the 4x4 support column at the SE exterior is deteriorating at its base where it is in direct contact with the ground; and (5) the stairway railing is quite loose and should be secured for safety reasons. A qualified contractor may very well advise additional repairs and improvements; further evaluation is advised. See attached pictures.

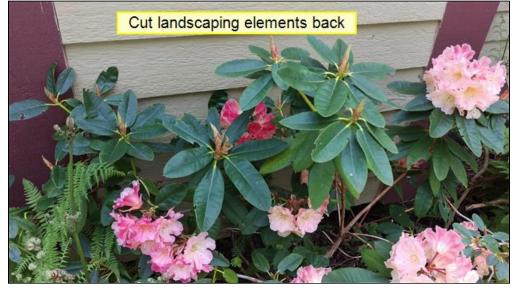
2.4 Item 1(Picture)

REPAIR: Landscaping elements and vegetative growth should be trimmed away from the building exterior to prevent moisture and insect damage. Eighteen inches clearance is recommended; when not practical, avoid direct contact between vegetative growth and the building envelope. Visual inspection of the exterior elements is restricted by landscaping elements that are in direct contact with and obscuring the building's exterior from visual inspection. See attached picture.

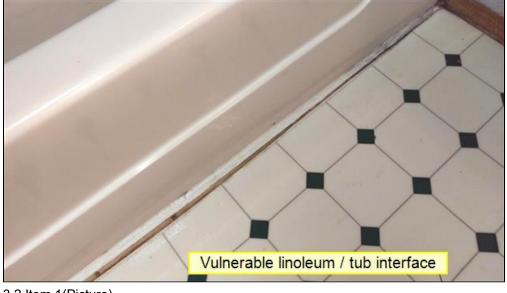
3.2 Item 1(Picture)

Repair: The linoleum adjacent the upstairs tub/shower enclosure appears to have receded, exposing underlying plywood sheathing, which is vulnerable to water damage. I recommend sealing this vulnerable interface. See attached picture.

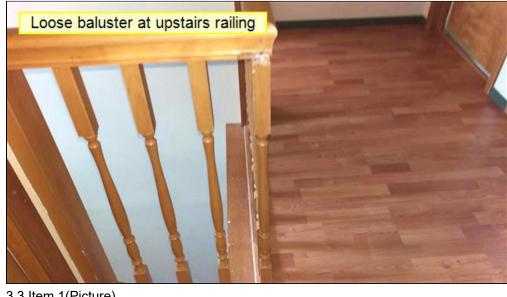
3.3 Item 1(Picture)

Repair: A loose railing baluster was noted at the upstairs railing system. See attached picture.

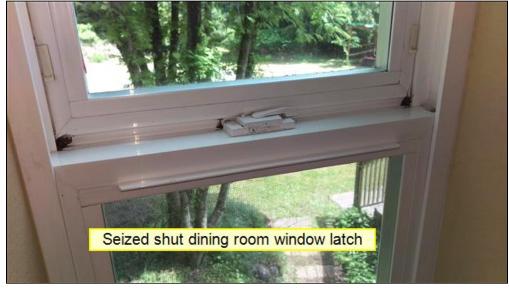
3.6 Item 1(Picture)

Repair: The upstairs dining room east single-hung window latch is stuck and not functional; some of the other window latches were tight and difficult to operate. See attached picture.

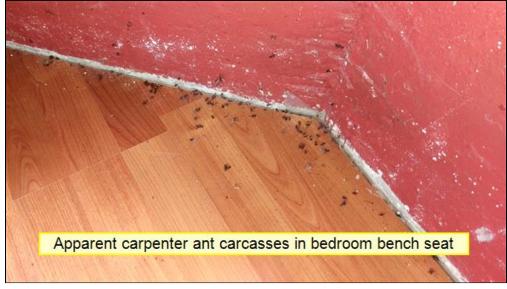
4.1 Item 1(Picture)

Repair: Apparent dead carpenter ant carcasses were noted in the basement bedroom storage bench seat, suggesting historic activity. This is in the area where deteriorated LP InnerSeal siding was noted; there is the

123 Sample Lane Page 27 of 58 possibility of underlying structural and insect damage not visible without invasive inspection. Further evaluation is strongly advised. See attached picture.

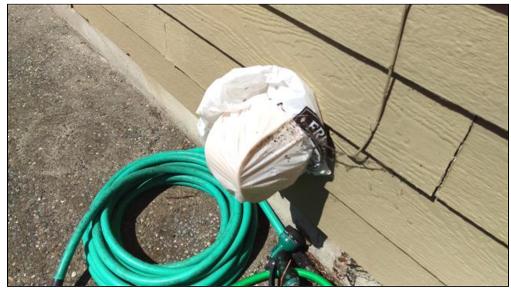
5.1 Item 1(Picture)

(1) **FYI:** Exterior hose bibs with installed outdoor faucet covers were not tested. See attached picture.

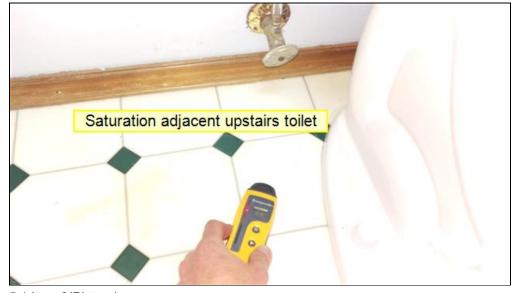
5.1 Item 2(Picture)

(2) **Repair**: The subfloor adjacent the toilet is saturated when probed with a moisture meter; I recommend further evaluation by a qualified contractor to pull and reset the toilet and make necessary repairs. See attached pictures.

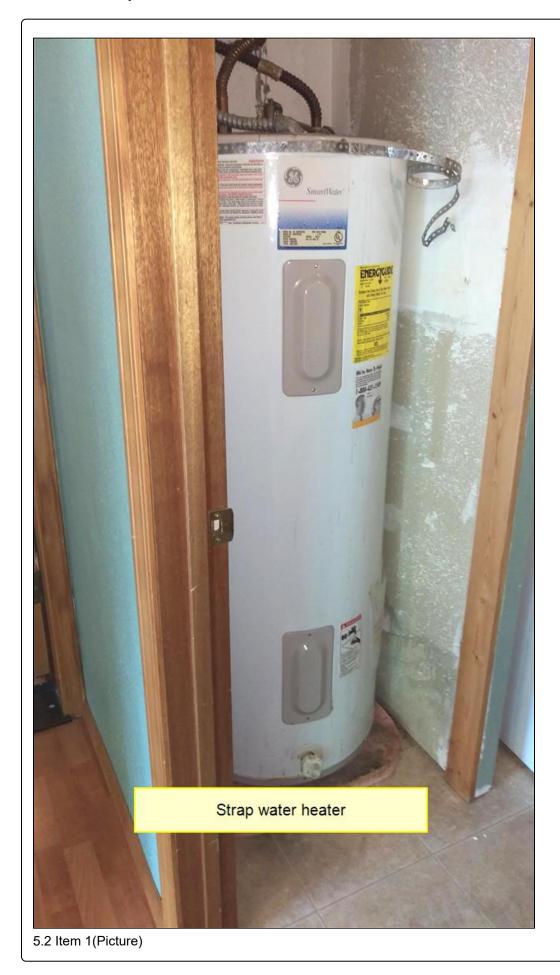
(2) **REPAIR**: Strapping the water heater at the top and bottom 1/3s of the appliance is advised, as customarily required in seismic zones. The top strap of the water heater is not fully secured. See attached picture.

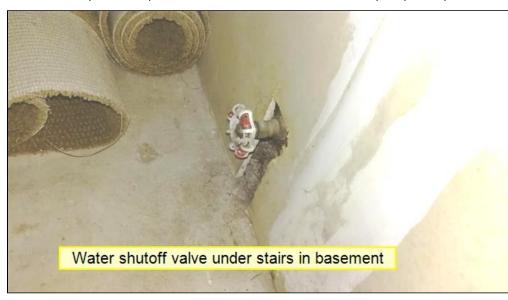
5.3 Item 1(Picture)

Street Meter (see video) and Valve in Basement Under Stairs (see picture)

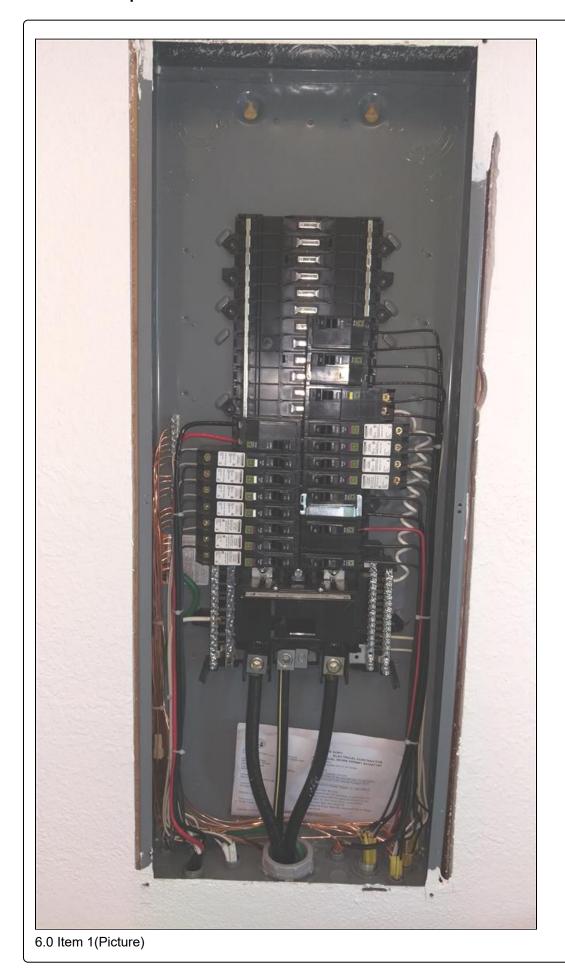
The electrical panel is well arranged, appears professionally installed, showed no evidence of electrical events or installation deficiencies, and was in satisfactory condition at the time of inspection. A thermal scan of the breakers and wiring did not show any overheating issues. See attached picture and video of panel interior.

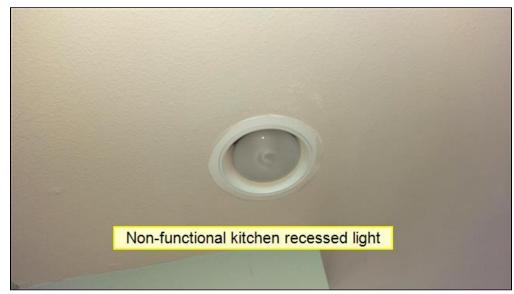
6.3 Item 1(Picture)

(1) Repair: A few light fixtures did not function at the time of inspection. This is typically due to blown or missing light bulbs. I recommend installing new light bulbs to verify proper fixture function. This was noted at the kitchen recessed light fixture and the basement-level southern exterior light fixture. See attached pictures.

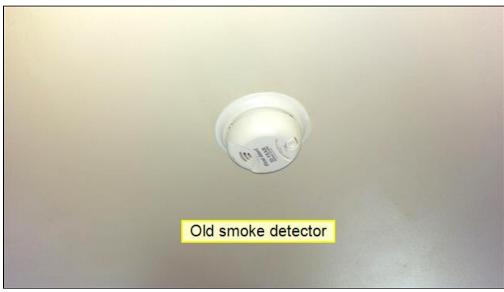
6.7 Item 1(Picture)

Safety Issue: Some of the smoke detectors have been intentionally disconnected. Replace smoke detector batteries upon possession and at manufacturer's recommended intervals thereafter. Replace smoke detectors every ten (10) years. See attached pictures.

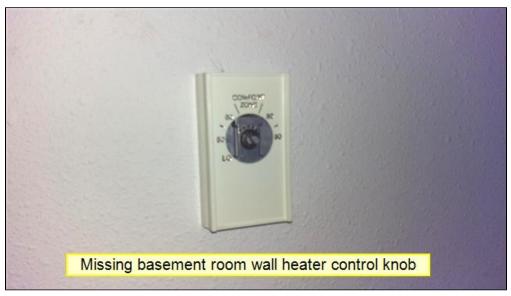
7.0 Item 1(Picture)

(1) **Repair**: The Cadet electric wall heater in the basement storage room did not function at the time of inspection and its control knob is mechanically damaged. All other wall heaters throughout the house functioned satisfactorily at the time of inspection with no noted defects. See attached pictures.

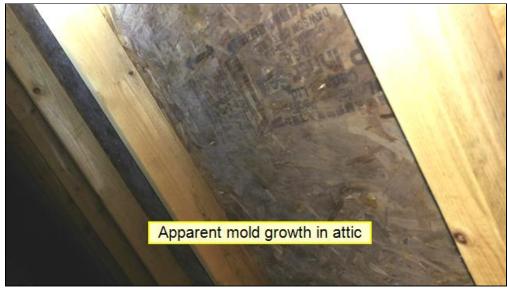
8.3 Item 1(Picture)

Repair: Evidence of insufficient ventilation and elevated moisture conditions, presenting as apparent mold growth on sheathing within the attic should be further evaluated, repaired and remediated by a qualified contractor. This was noted to a fairly significant extent throughout the attic. A possible contributing factor may very well be insufficient ridge ventilation; I recommend a qualified contractor further evaluate the ventilation within the attic area, make necessary repairs, and then properly remediate and encapsulate apparent mold growth throughout. See attached pictures/video.

contractor. This was noted to a fairly significant extent throughout the attic. A possible contributing factor may very well be insufficient ridge ventilation; I recommend a qualified contractor further evaluate the ventilation within the attic area, make necessary repairs, and then properly remediate and encapsulate apparent mold growth throughout. See attached pictures/video.
