Inspection Report

HomeBuyers Inspection

33977 Stara Lane, Hendersonville, NC

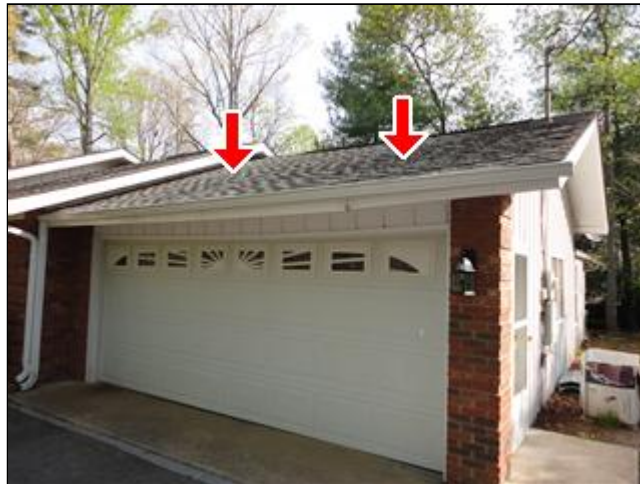
1.0 Picture 1

- 🔍 (1) Evidence of a leak in the Den below corresponds with the middle skylight roof and flashing area. Repairs are needed. Recommend a qualified contractor inspect further and repair as needed.
- 🔍 (2) The roof covering was installed improperly above garage. Roof sheathing needs to be replaced in this area. This will involve some shingle replacement. A qualified contractor should inspect and repair as needed.

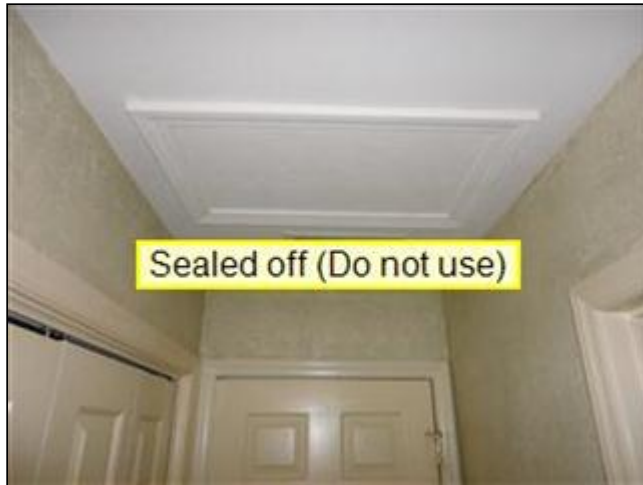
1.5 Picture 1

No longer an attic access. Use the pull down stairs at garage.

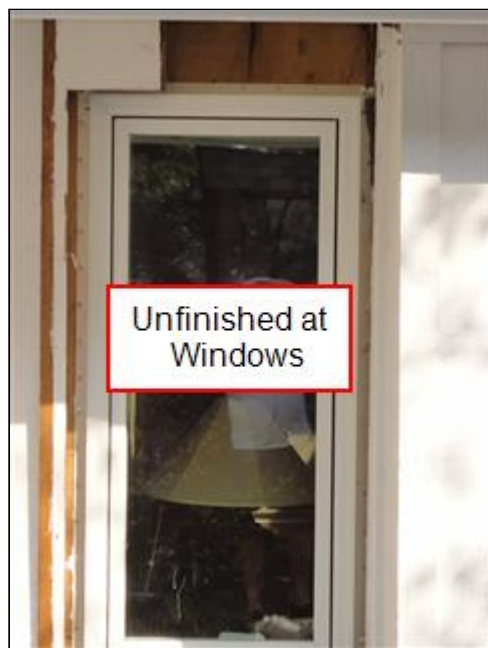
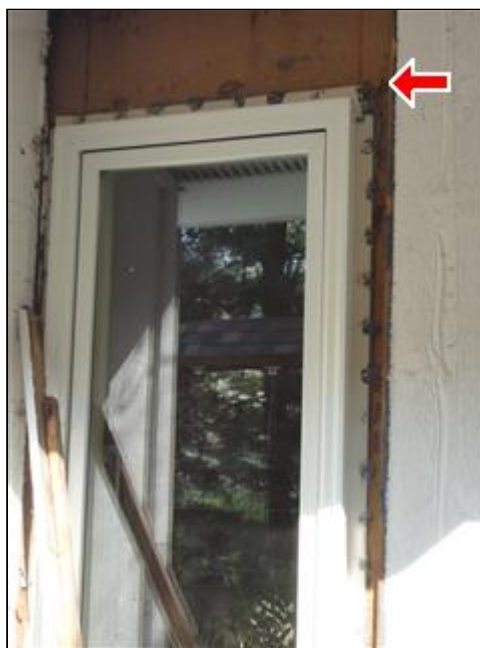
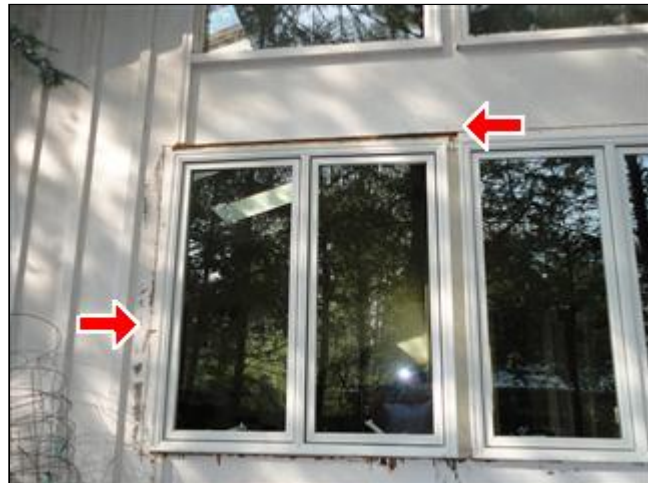
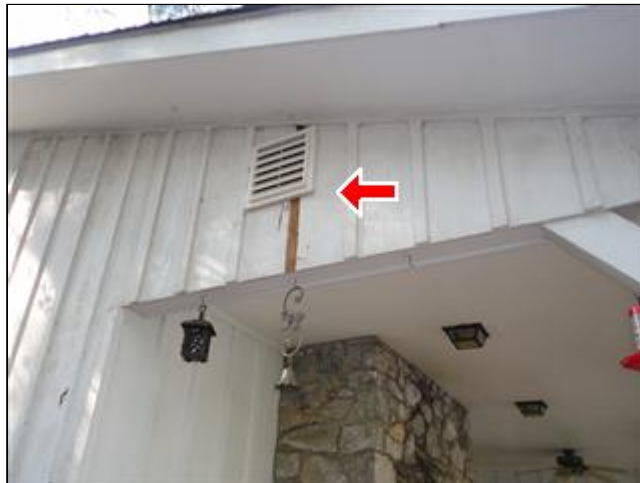
2.0 Picture 1

- 🔍 The Wood siding at the right side (facing front) and rear of home is missing or incomplete at time of inspection around new premium windows that have recently been installed. I did not inspect the installation of siding at this location. A qualified contractor should inspect and repair as needed. The siding will need prep and paint.

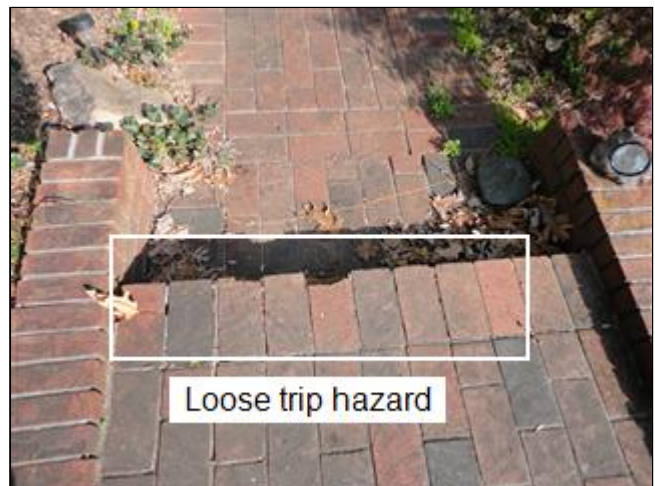
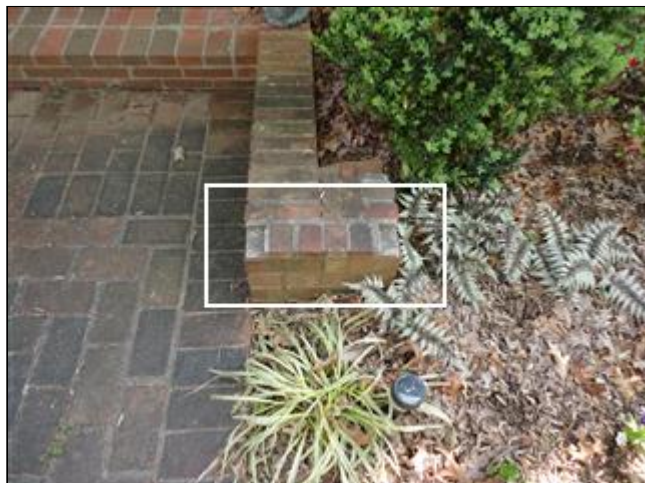
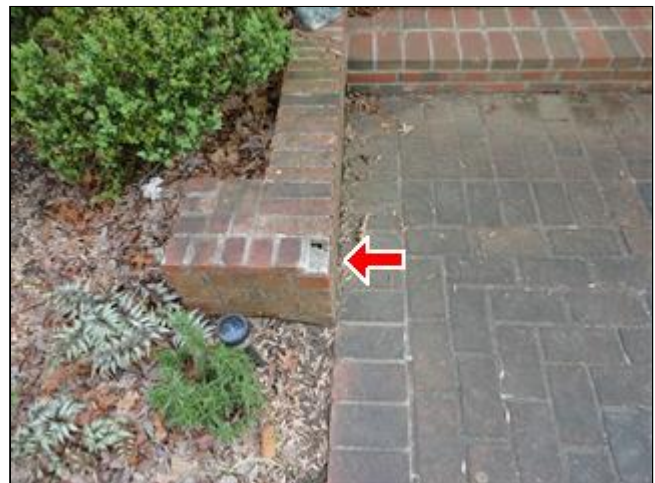
2.4 Picture 2 Water signs at front step

- (2) The brick walkway at the front of home are deteriorated in areas. A general replacement is likely. A qualified contractor should inspect and repair as needed.

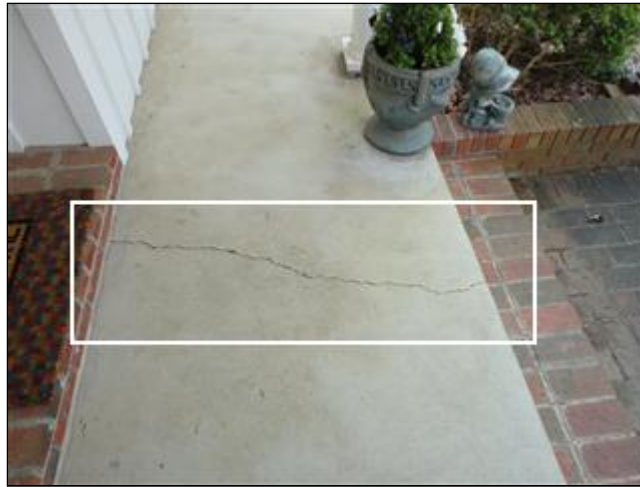
2.4 Picture 6

(3) Concrete is cracked at front entrance of home. Appears to only affect the slab itself and is more cosmetic.

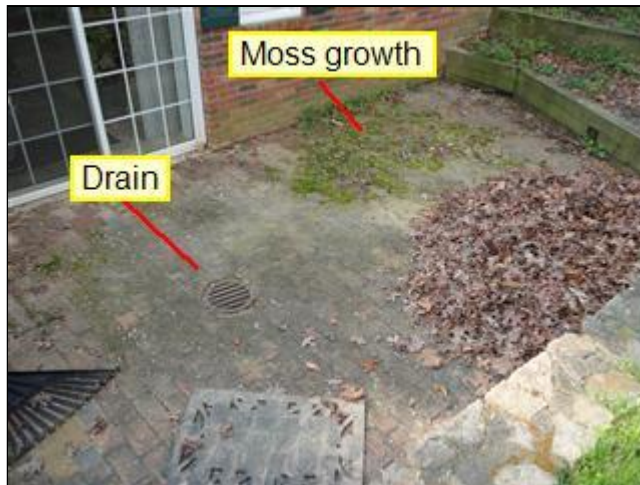
2.4 Picture 7

🔍 (4) The brick floor on the patio at the left side (facing front) has deteriorated mortar or grout, and is loose and uneven in areas. Water can cause further deterioration if not repaired and sealed properly. A qualified contractor should inspect and repair as needed.

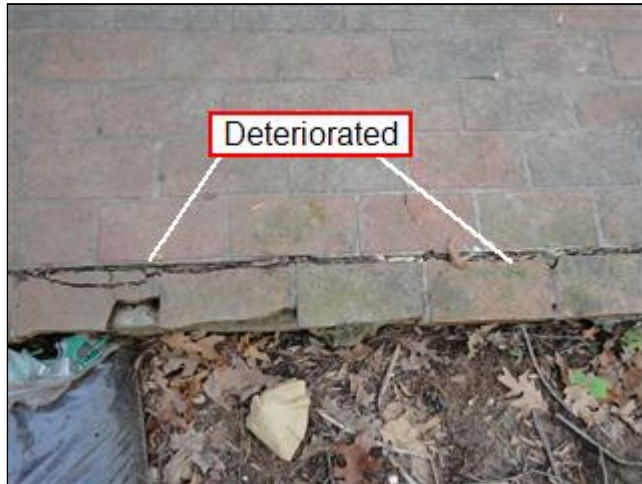
2.4 Picture 8

- 🔍 (5) The brick floor on the patio at the rear of home is old and deteriorated. A general replacement is likely. A qualified contractor should inspect and repair as needed.

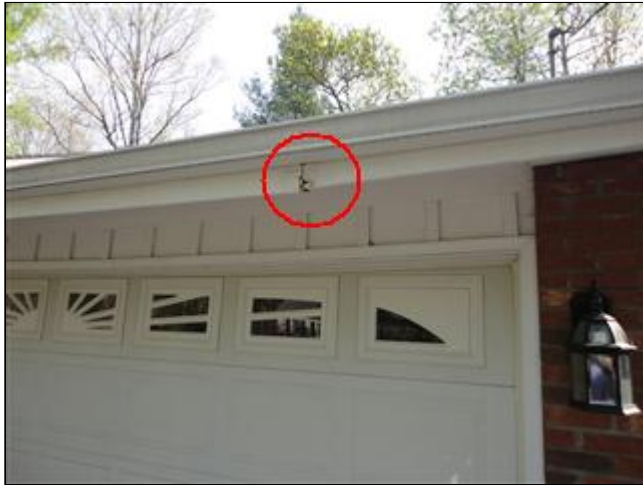
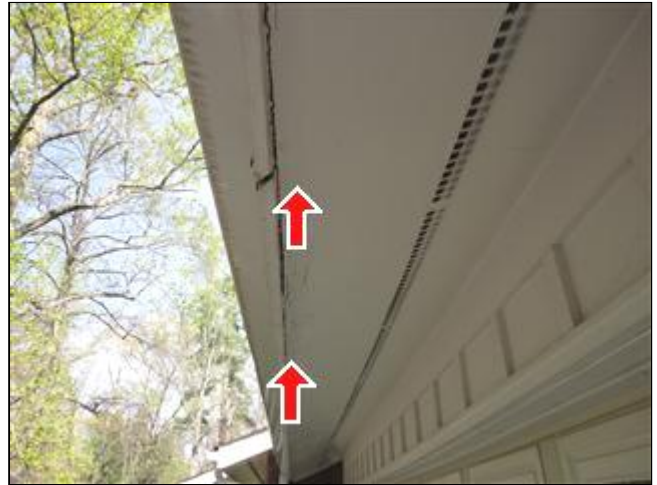
2.5 Picture 1

- 🔍 (1) The wood fascia and soffit panels at eave on the front of home above garage are deteriorated. Repairs are needed to roof covering as well. A qualified contractor should inspect and repair as needed.

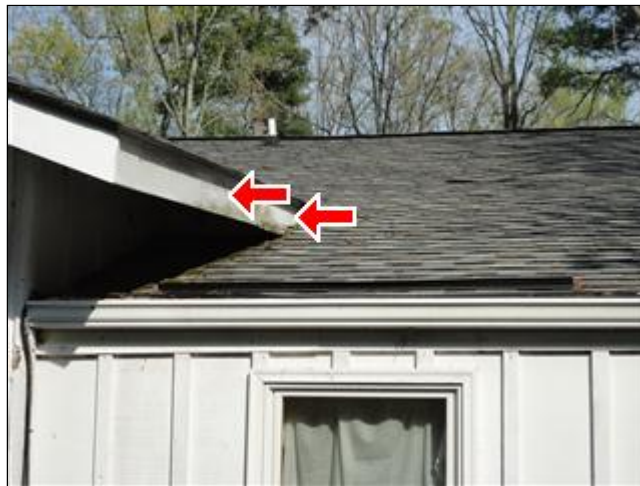
2.5 Picture 3

- 🔍 (2) The wood fascia at eave on the right side (facing front) is deteriorated. This is a small repair. A qualified contractor should inspect and repair as needed.

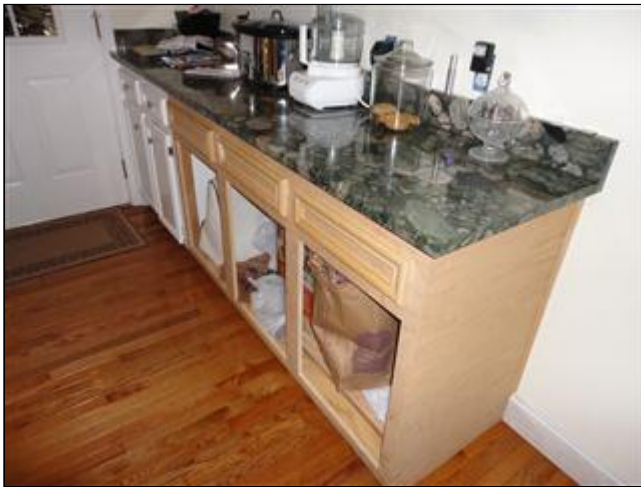
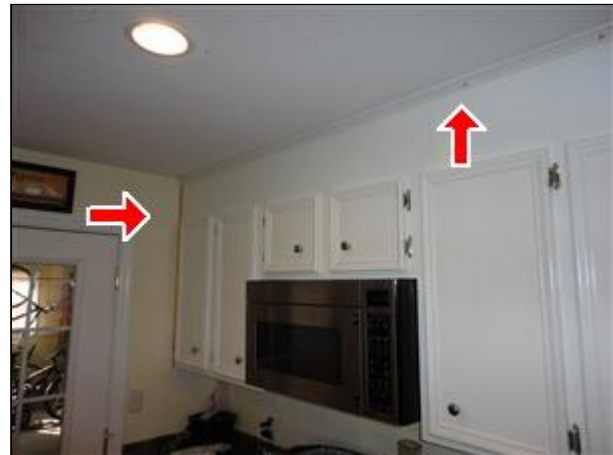
4.5 Picture 1

🔍 Base Cabinetry and trim at wall cabinet are unfinished at kitchen.

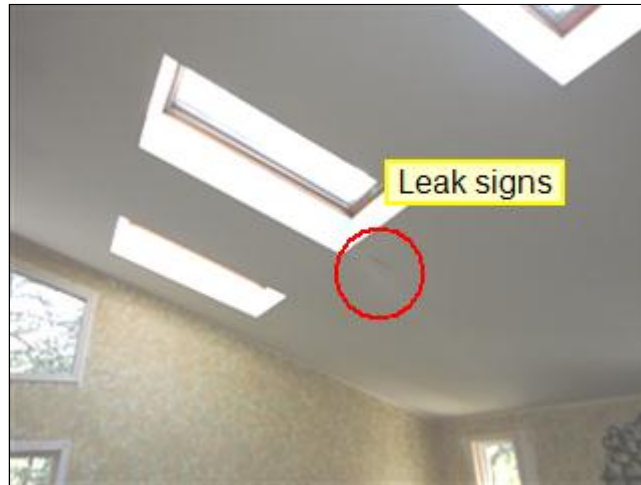
5.0 Picture 1

- 🔍 (1) The Sheetrock on the ceiling reveals a water stain indicating a leak did or still exists at the Den. Repairs are needed. A qualified contractor should inspect and repair as needed (See Roof Coverings).

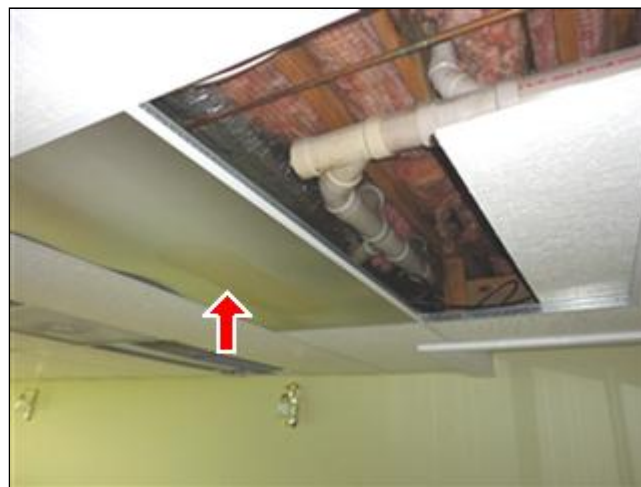
5.0 Picture 2

- 🔍 (2) Water stain on ceiling panel lower level indicates plumbing leak.

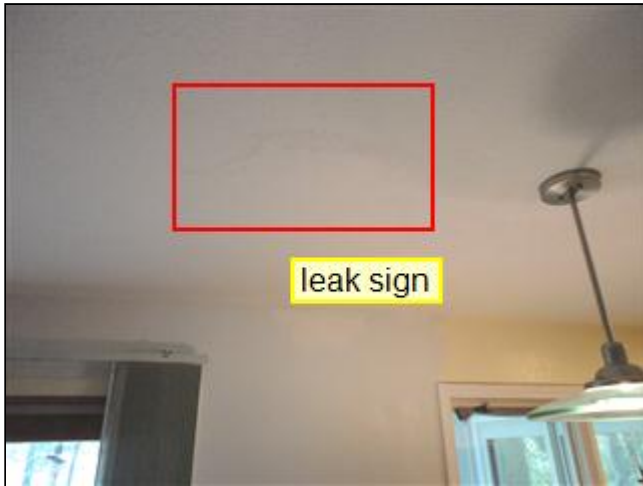
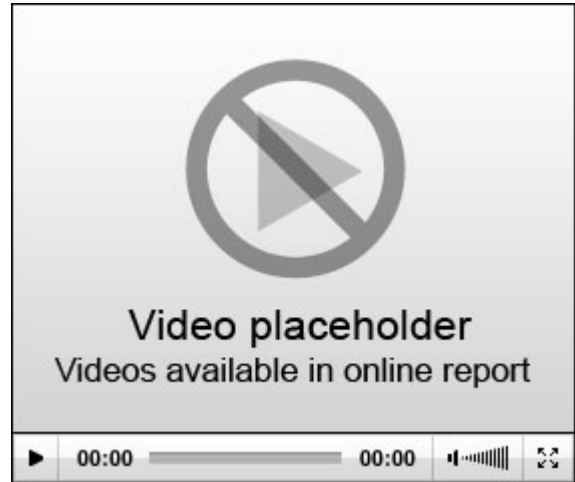
5.0 Picture 3

- 🔍 (3) The Drywall on the ceiling reveals a water stain indicating a leak did or still exists at the Dining Room. Repairs are needed. A qualified contractor should inspect and repair as needed.

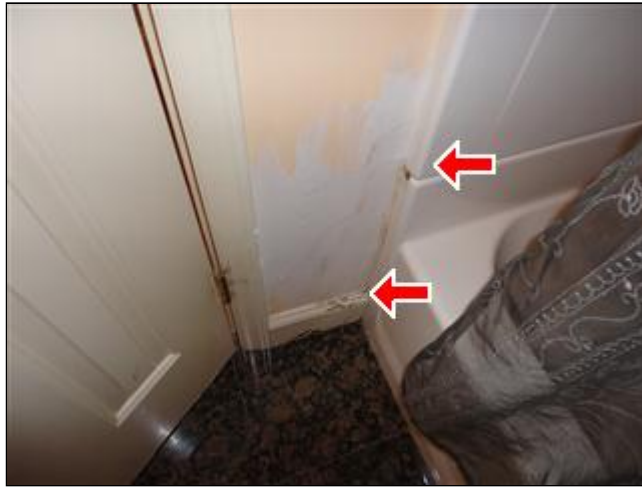
5.1 Picture 1

- 🔍 (1) Unfinished around windows in kitchen, and Den.
- 🔍 (2) The Wall at the bathtub is deteriorated and needs repair or replacement. The wall board and framing may need repair (not visible). I recommend repair or replace using a qualified contractor.

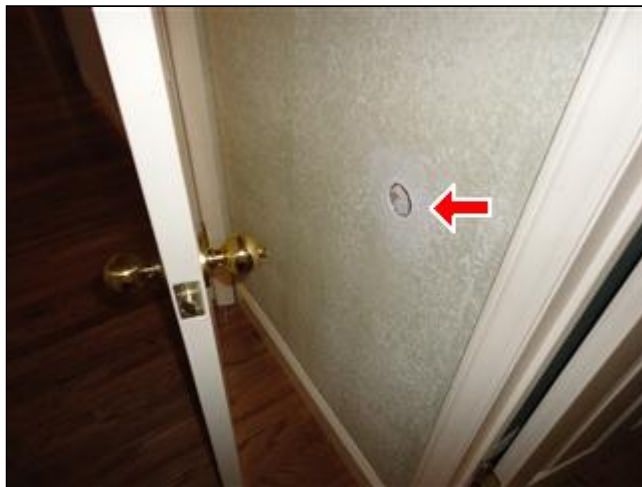
5.1 Picture 2

- 🔍 (3) The sheetrock on the wall is dented or damaged from door knob at the hallway. While this damage is cosmetic, it needs to be repaired. A qualified contractor should inspect and repair as needed.

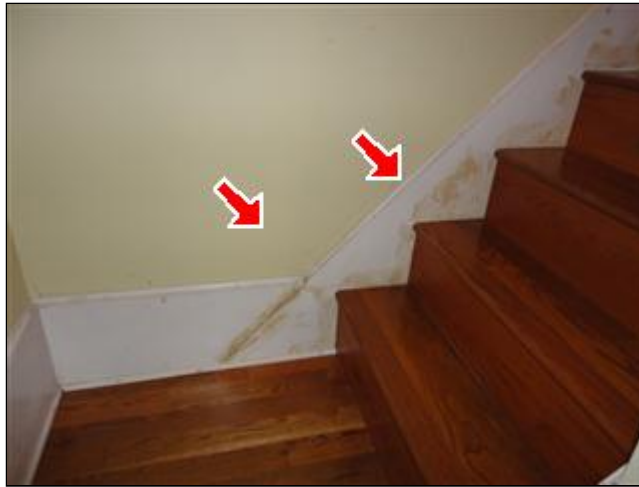
5.1 Picture 3

- 🔍 (4) Stair cover trim is unfinished needs prep and paint at stairs.

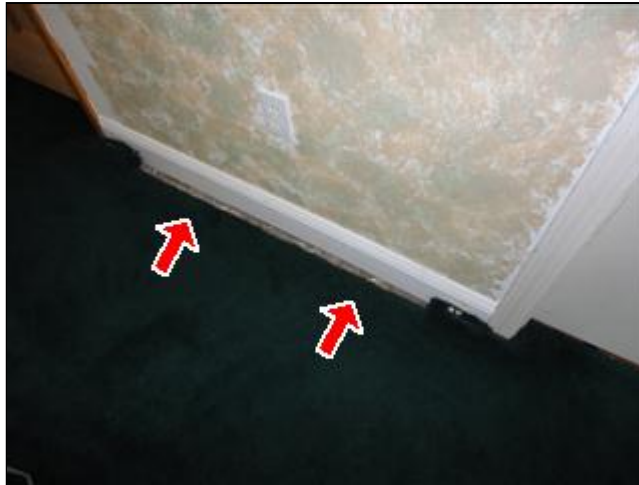
5.2 Picture 1

- 🔍 Carpet is loose or cut short from where electric baseboard use to be in areas around the perimeter of the Den.

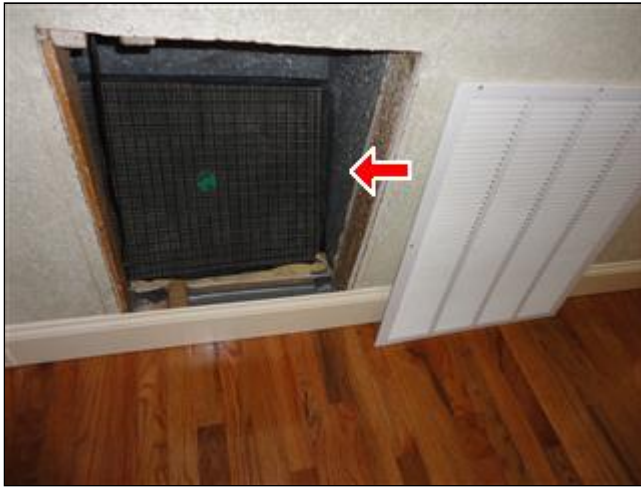
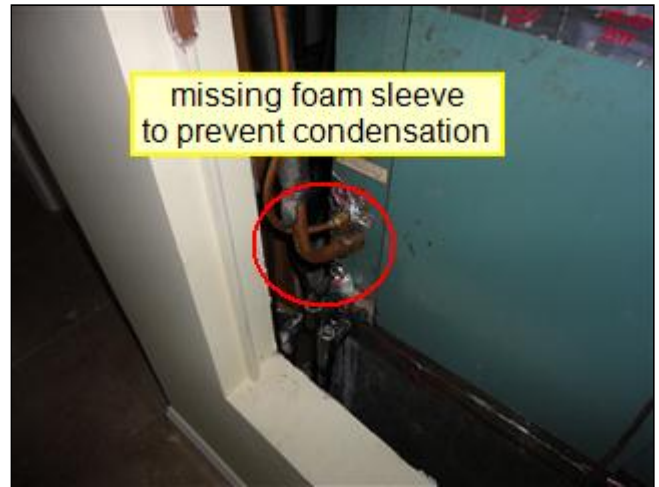
10.3 Picture 1

- The washable filter is dirty. The filter needs to be cleaned. Recommend foil taping the filter for a better seal. See Video. Foam sleeve missing at suction line creates condensation and drips water.

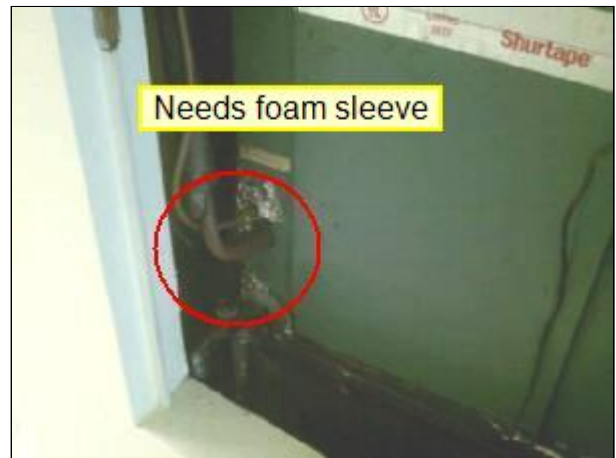
10.8 Picture 1

Air handler and heat pump is old but appears to be working properly. Foam sleeve on suction line is not covering copper line and condensation can drip.
